TARGETED BROWNFIELDS ASSESSMENT PHASE I ENVIRONMENTAL SITE ASSESSMENT 1201 EAST 11TH STREET AUSTIN, TEXAS 78702

Prepared for United States Army Corps of Engineers
Fort Worth District
November 29, 2010

Baer Engineering and Environmental Consulting, Inc.
7756 Northcross Drive, Suite 211, Austin, Texas 78757
Phone: 512/453-3733; Fax: 512/453-3316
Baer Project No. 102043-8i.010

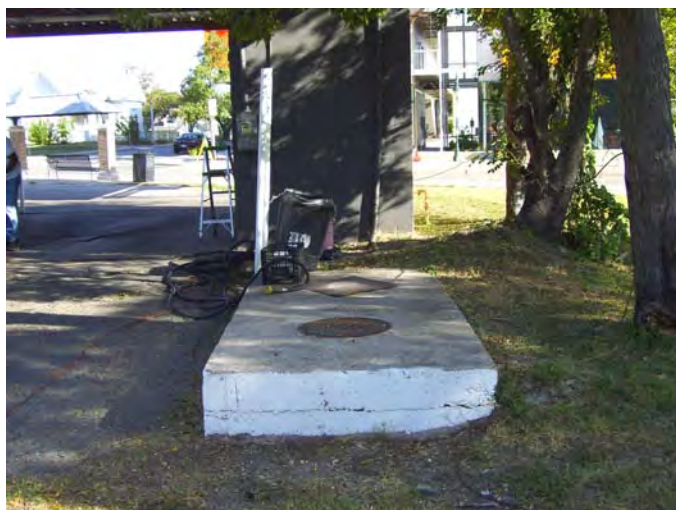
Photograph 5.

The wastewater system at the Site collects liquid from vehicle washing and the restroom. The liquid may contain petroleum hydrocarbons, VOCs, and metals. The wastewater line from the Site to the municipal wastewater collection system is plugged. If the line is broken, wastewater from the Site may be leaking to the soil and groundwater.

- The wastewater system at the Site includes a 1500-gallon vault that collects liquid from vehicle washing bays and a restroom. The plumbing from the vault to the municipal wastewater sewer is clogged for unknown reasons. The plumbing may be broken, and if it is, liquid from the vault may be leaking to the soil or groundwater. Baer Engineering considers the potential for petroleum hydrocarbons, metals, and VOCs to be released to the environment, from the wastewater system, to be a REC.

A 1500-gallon concrete vault is located near the east end of the car wash building. It is part of the wastewater system.

Baer Engineering recommends that a Phase II ESA be conducted to determine if potential contamination from the RECs has affected the Site. Soil and groundwater samples should be collected from the former underground tank locations on the north part of the Site, along the west side of the Site, and near the wastewater line that connect the vault with the municipal sewer beneath Lydia Street. Samples should be analyzed to determine the impact from VOCs, the RCRA-8 metals, and petroleum hydrocarbons.

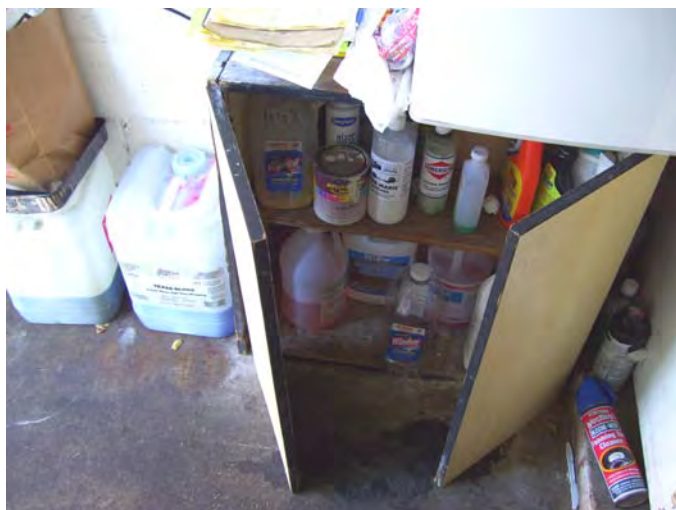
Photograph 6.

A cabinet inside the car wash restroom area that is used to store cleaners.

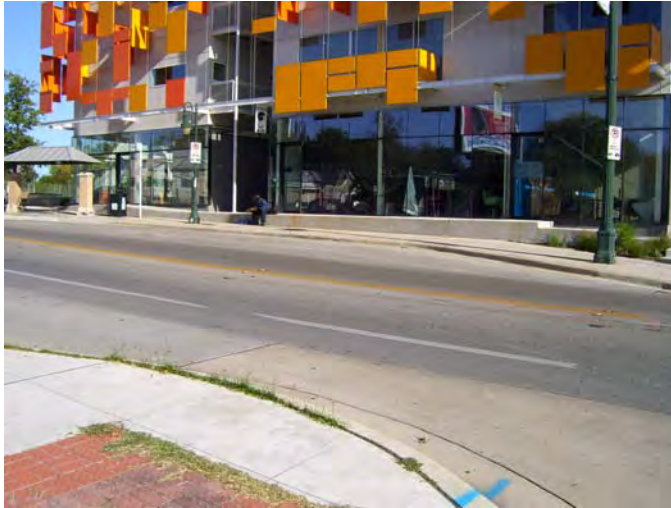
Photograph 7.

- Previous groundwater sampling by others has detected low concentrations of VOCs at the property adjacent to the north of the Site. The source of the VOCs is not known. Benzene and other compounds typically found in petroleum fuels were found, suggesting that a release or releases of petroleum may have occurred. Baer Engineering considers the presence of VOCs in the groundwater beneath an adjacent property to be a REC.

The property on the north side of 11th Street and adjacent to the Site.
